# SaveEnergy

## SaveEnergy Thermal Imaging Assessment Report for Bledlow Ridge School

14th September 2026

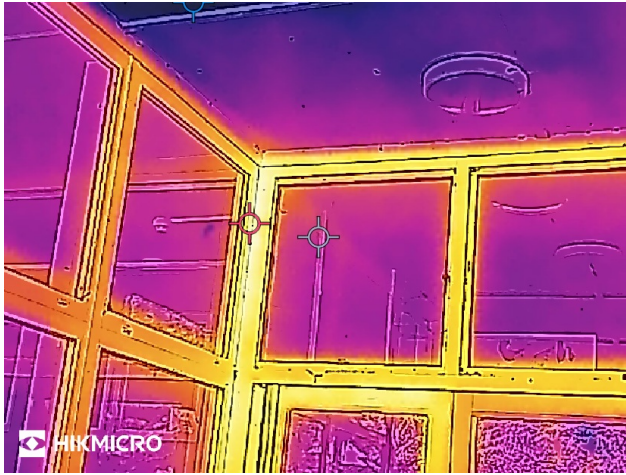
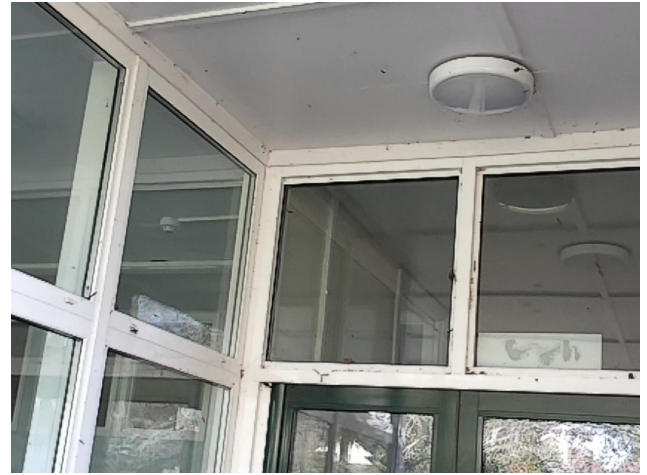
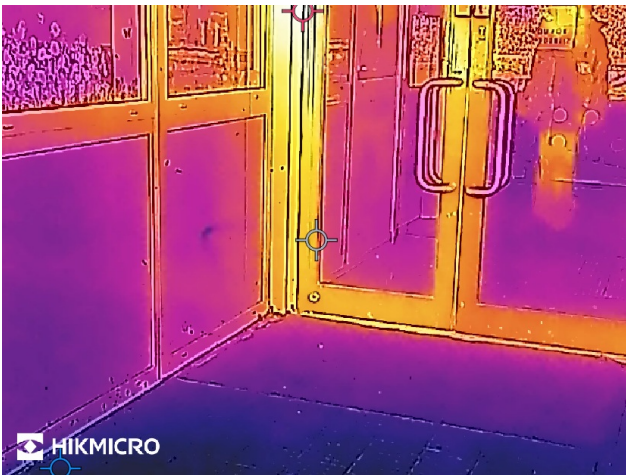
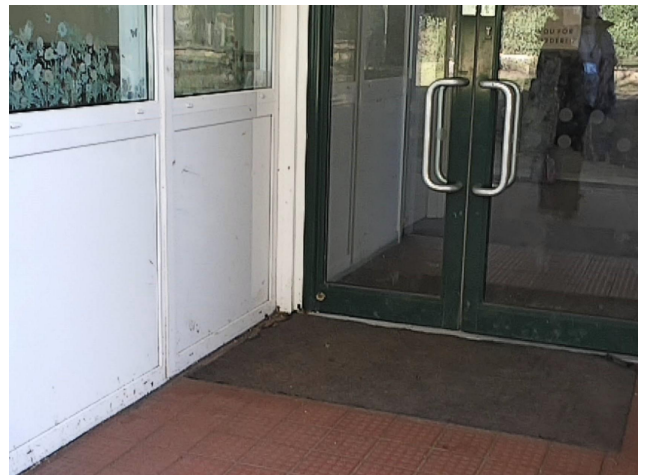
The front entrance of the school is mainly glazed, with insulated infill panels set into the PVC frame at ground level on this side. These frames are the hottest part of the image and demonstrate the heat loss that is occurring all around the school. The ambient temperature at the time that these photographs were taken was around 10°C, whereas the temperature of the frames is around 15°C – the frames are radiating heat into the atmosphere that is then having to be replaced with more heating, causing unnecessary heating bills and carbon emissions.

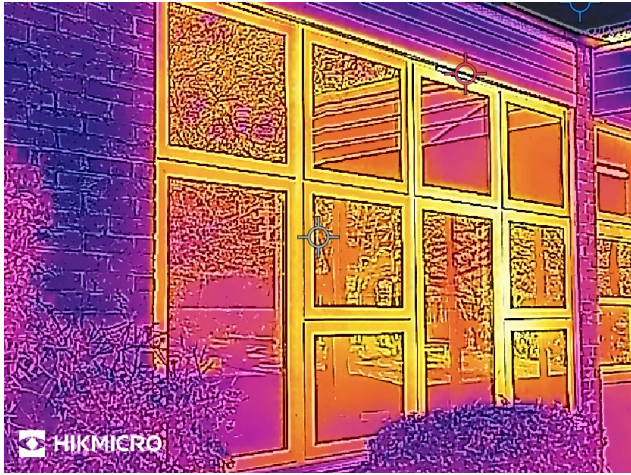
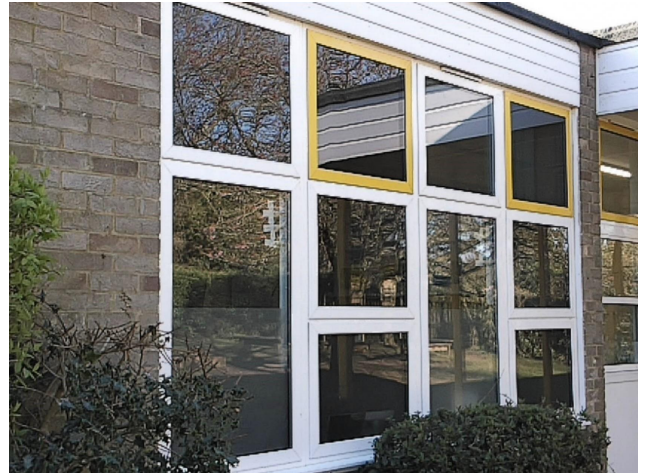
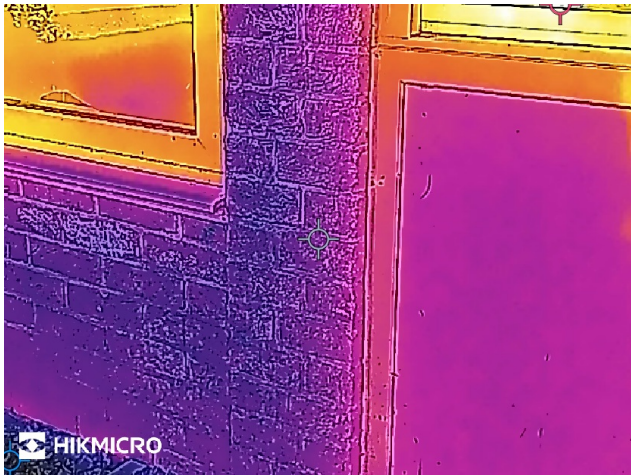
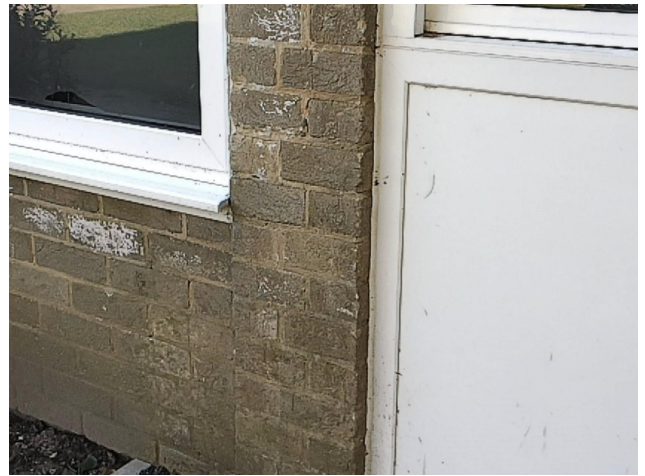
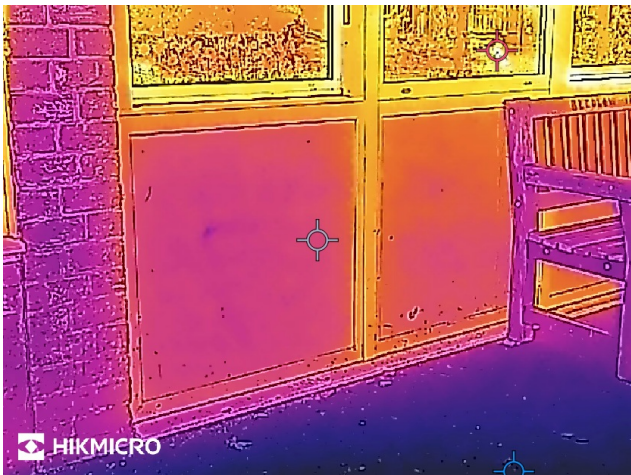
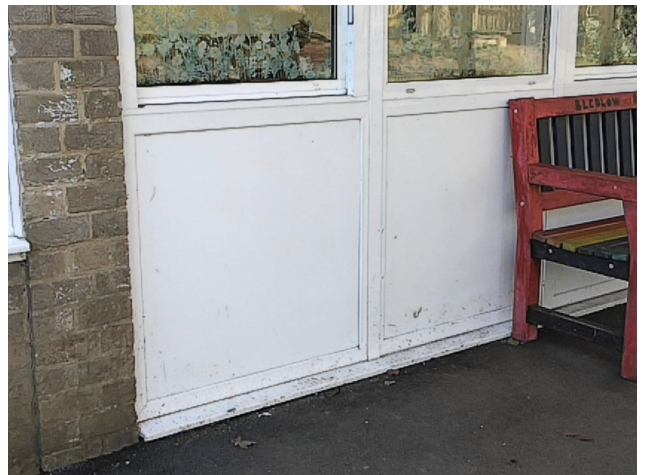
Moving round the school frontage, the story is consistent – the age and design of the window frames make them the thermally weakest part of the building. On inspection we were able to find evidence of the cavity walls having been filled, and the images confirm this as the walls are not radiating heat in the same manner as the windows.

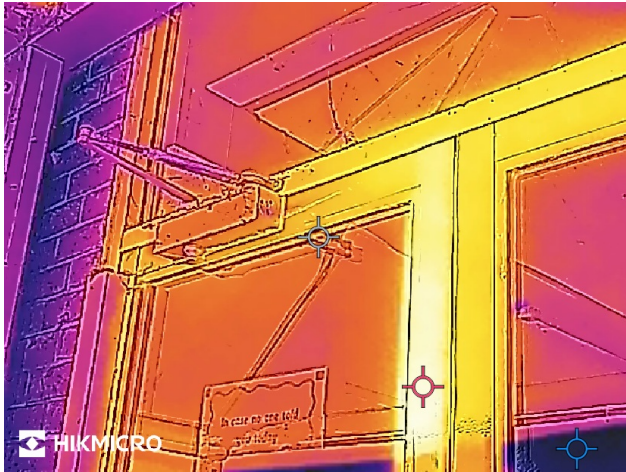
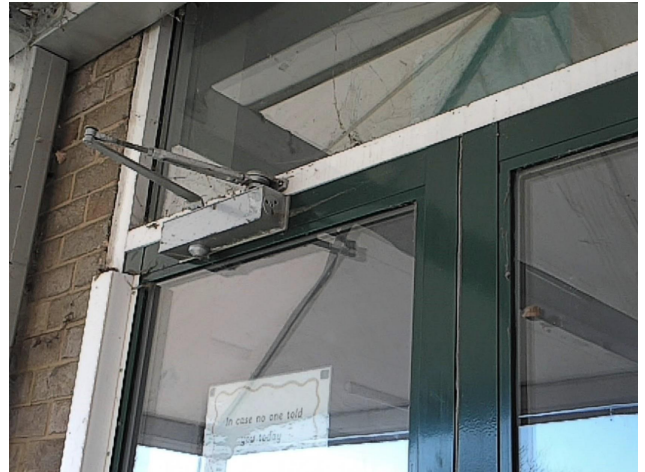
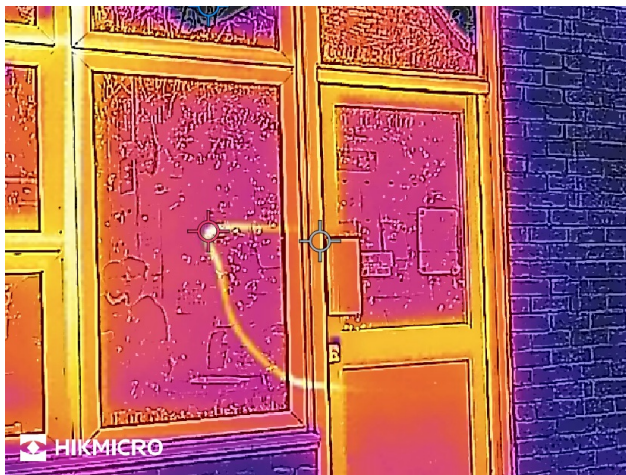
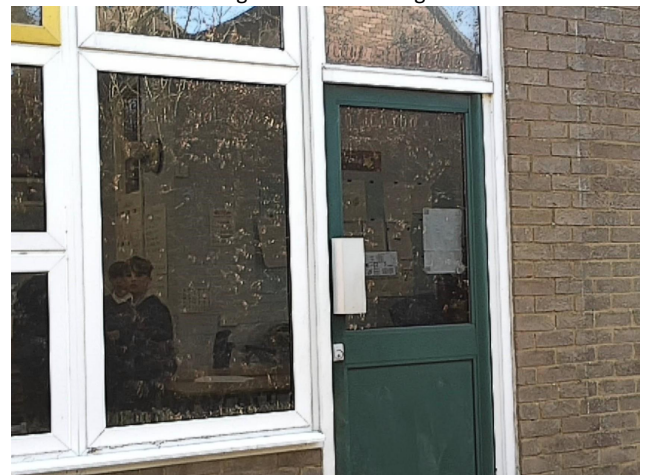
The metal frames of the doors are particularly good heat conductors and do not feature the thermal breaks and insulation that are now included in modern equivalent doors and windows, leading them to be particularly poor at stopping heat escaping. While the PVC frames in the previous images were measured at about 15°C, the metal door frame is at 20°C – room temperature, and is a significant source of heat loss.

Overall the school is well insulated at the walls and in the roof, with the main thermal weak area being the windows and doors. This is really just a function of age – while they are double glazed units, by comparison to modern standards they are quite inefficient and are certainly responsible for a significant proportion of the heat lost from the building. In particular the metal doors, while being strong and robust, are very poorly internally insulated and are conducting heat at the fastest rate – these might be a candidate for targeted replacement over time, to more thermally efficient versions that are currently available. Once these have been dealt with, the PVC windows should also be replaced over time, with more thermally efficient modern windows.

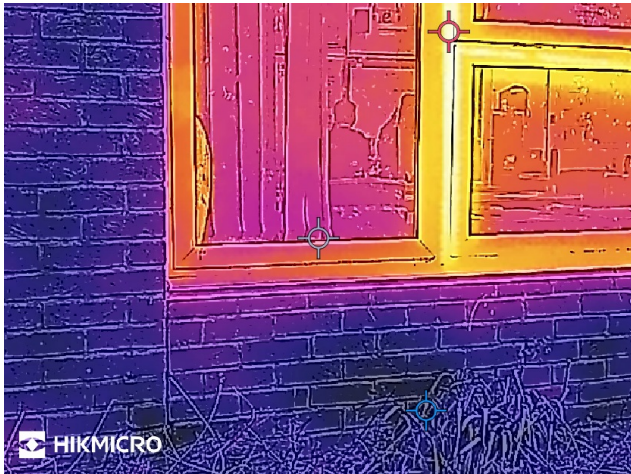
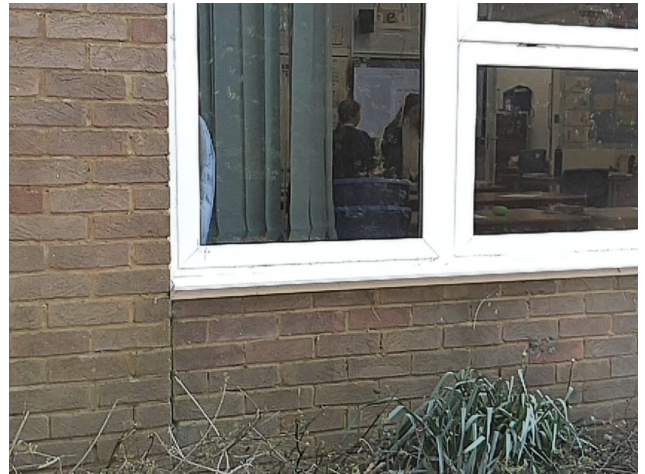
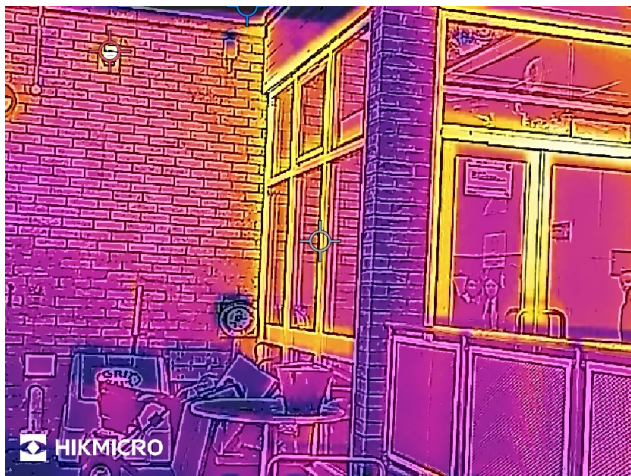
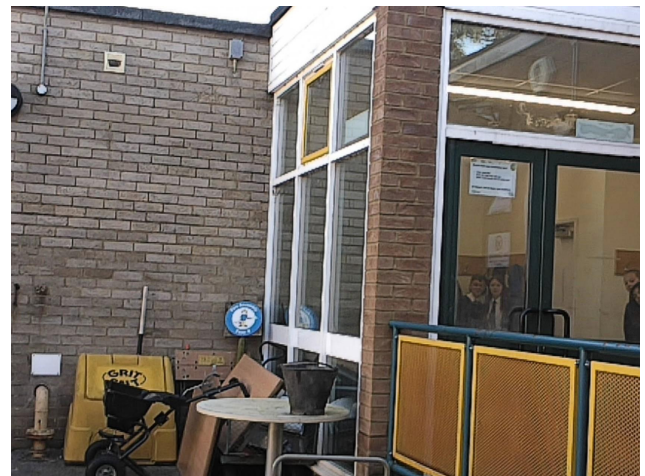
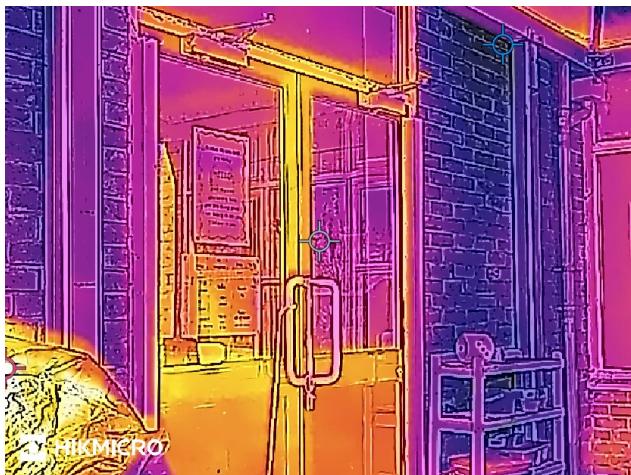
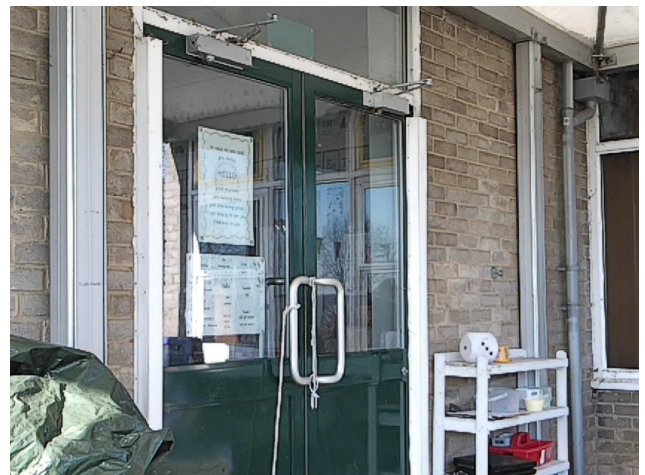
At the side of the school the story remains the same – cool walls (meaning that they are well insulated and are not conducting heat away from the building) and hotter window frames. As well as the generally low thermal performance of the windows, it would be worth checking the fit of individual windows in the frame – the top image here implies that there is hot air leaking from the joint between the window and its frame, and this is a relatively easy thing to fix with draught strip, or the realignment of the window mechanisms.

There were two smaller opportunities for efficiency improvements also identified – either some of the windows were very slightly open on the morning of the inspection, or the seals and fit between the opening parts of the windows and the frames that they sit in may need some adjustment to ensure that there are no draughts or unwanted ventilation. Likewise, in the classroom with the double external doors, there was daylight showing in the gap where they meet, and this can be fixed with by adjusting the mechanisms or adding draught excluder to the edges.

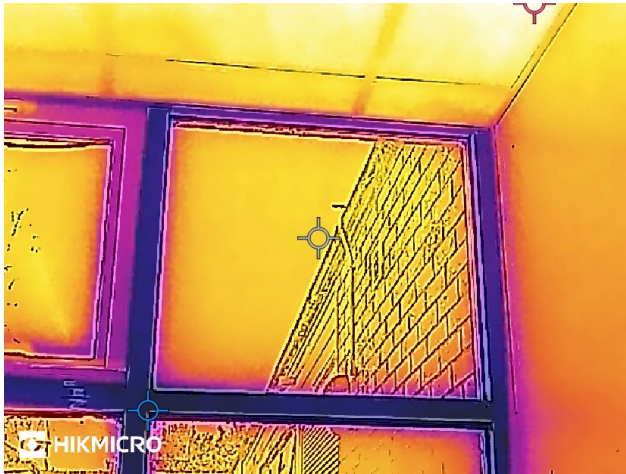
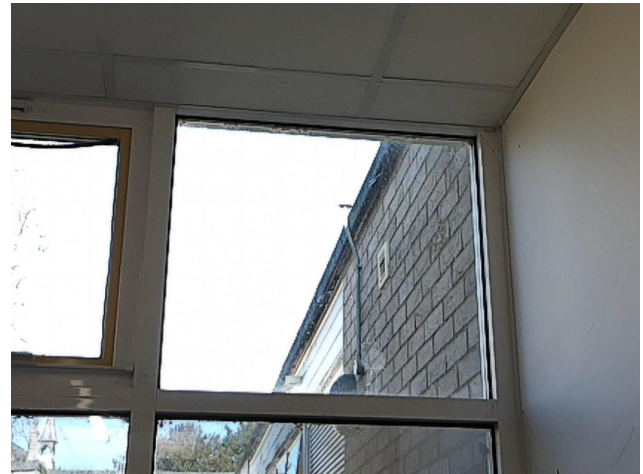
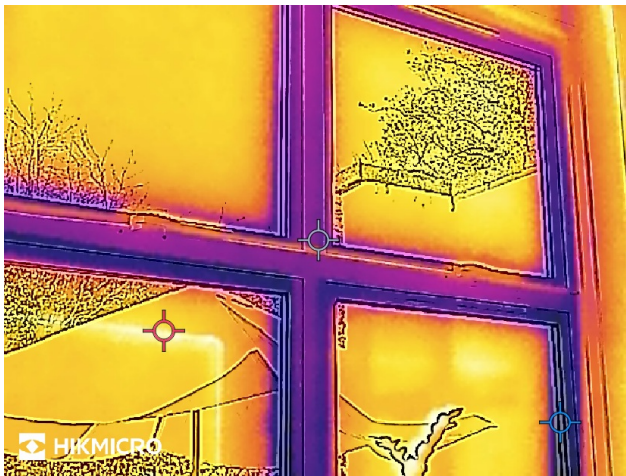
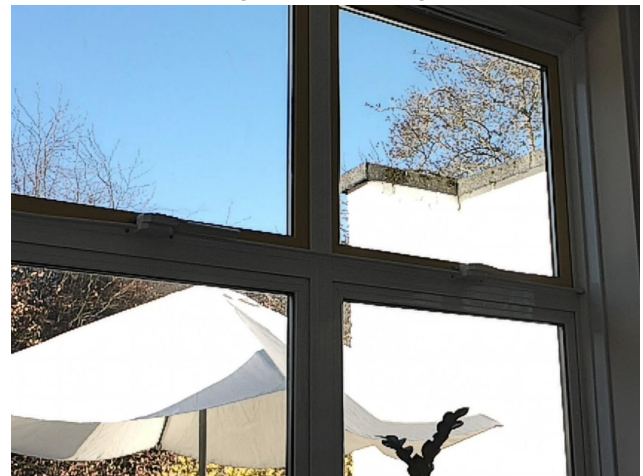
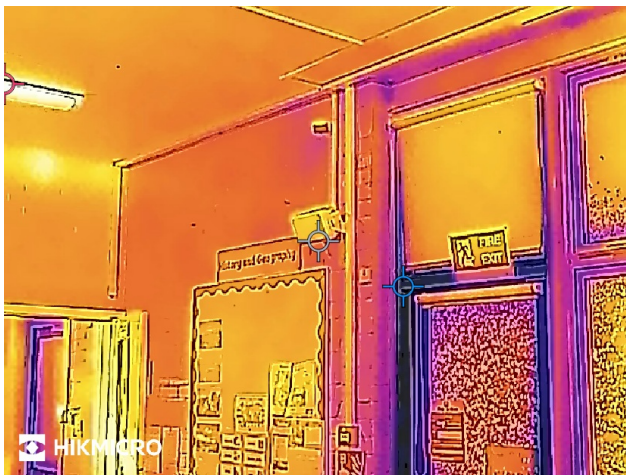
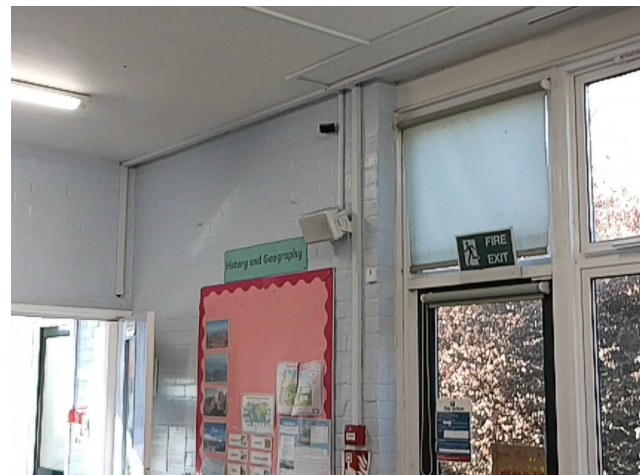
Moving inside the building the story is the same – the windows are now appearing much colder than the walls and ceilings, and are demonstrating the heat loss referred to previously.

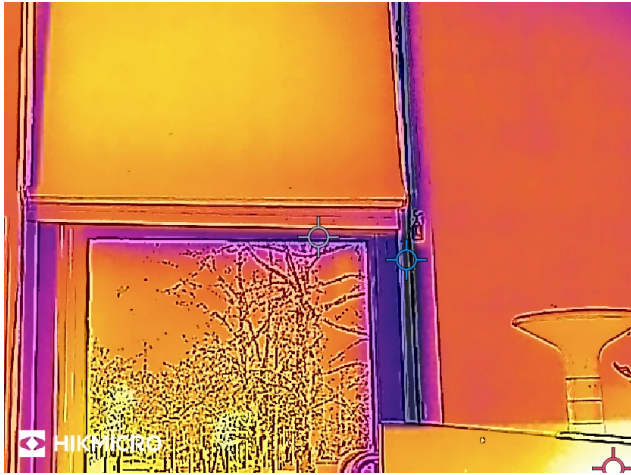
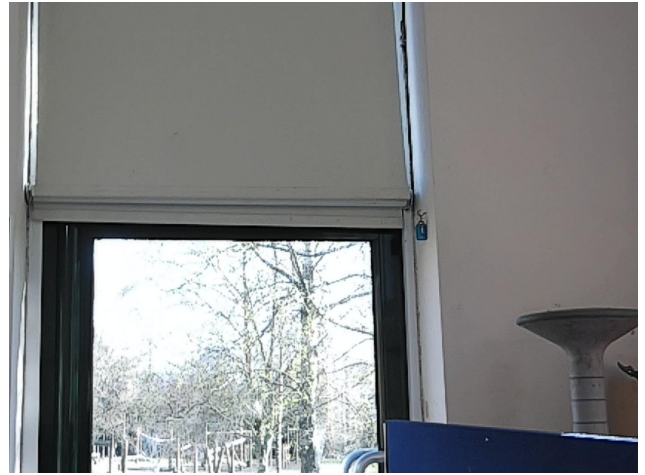
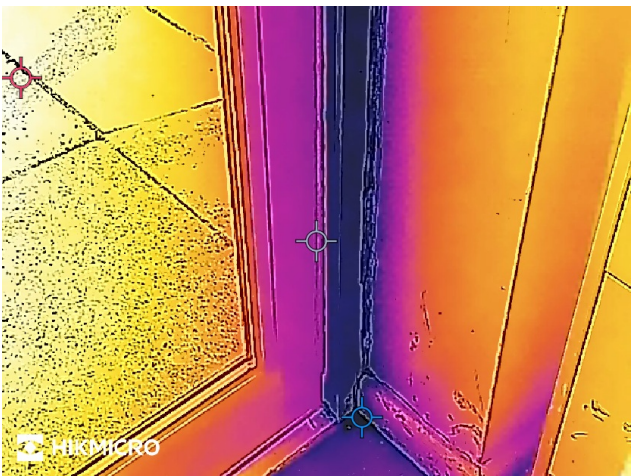
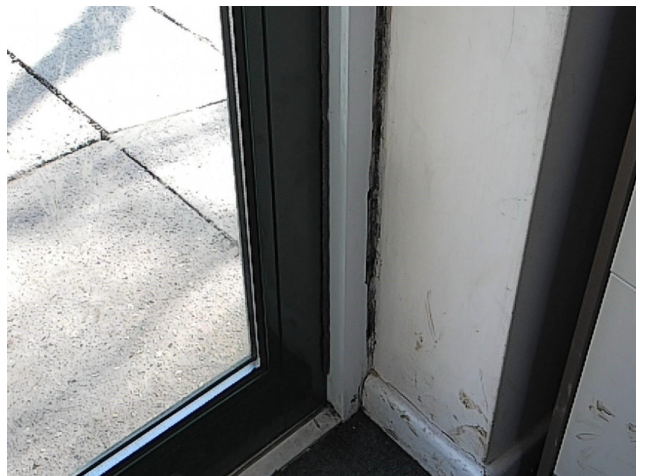
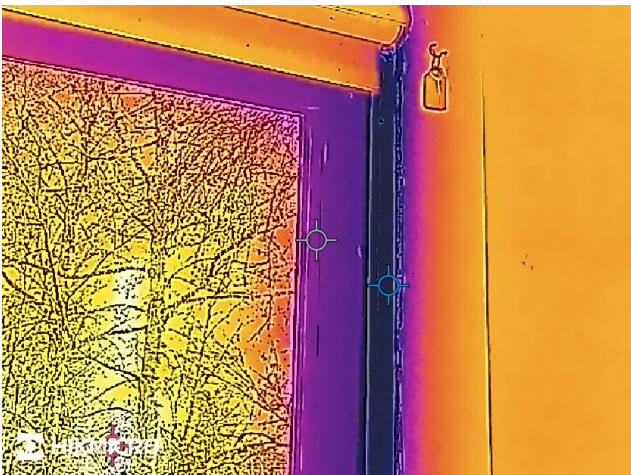
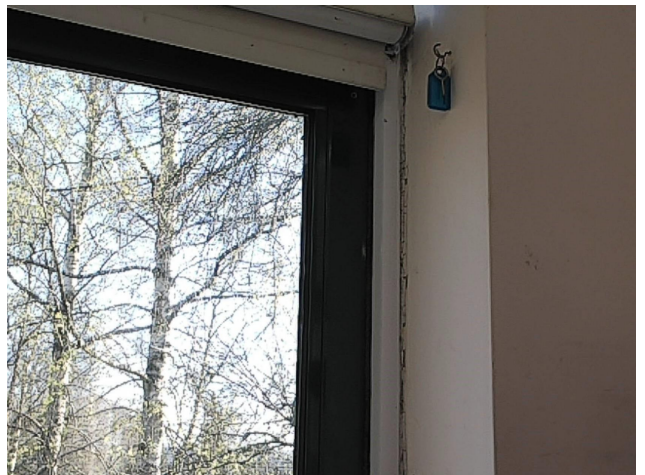
These images confirm that the metal framed doors are particularly poor at heat retention. The mould that can be seen at the edge of the door is caused by water vapour condensing at the coldest point in the room, which is consistently this frame.

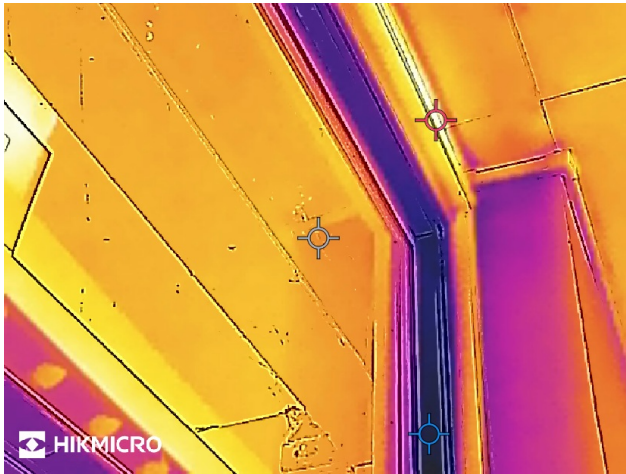
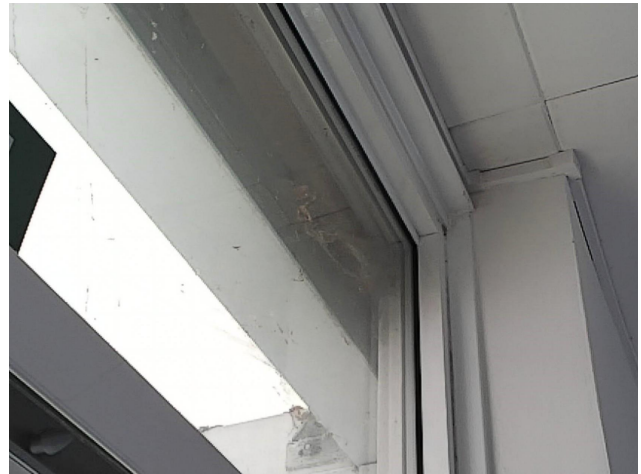
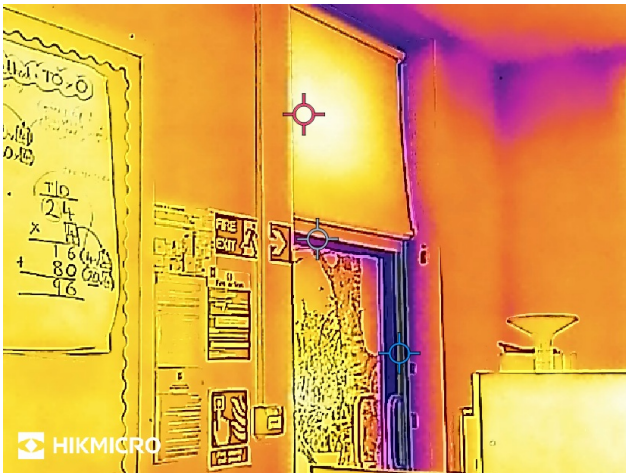
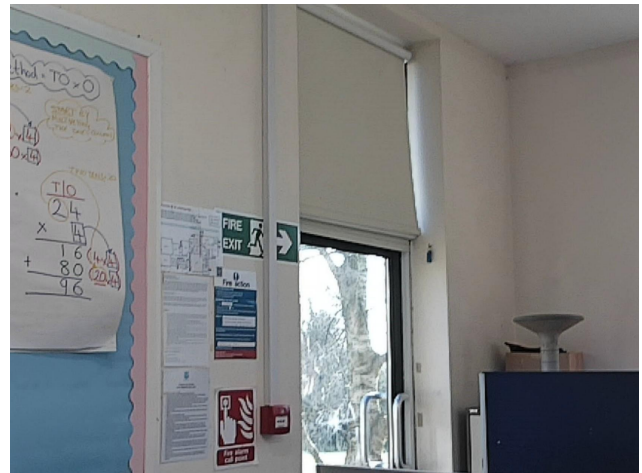
In some cases, the thermal weakness of the frame is causing the surrounding wall and ceilings to be chilled as well, through a process called thermal bridging. Unfortunately, there are no real options to reduce this issue, short of replacement of the doors (and eventually windows too) with modern, highly efficient replacement units that use thermal breaks and insulation, along with low emissivity glass, which would make a noticeable difference to both the comfort of the rooms but also a reduction in heating bills.

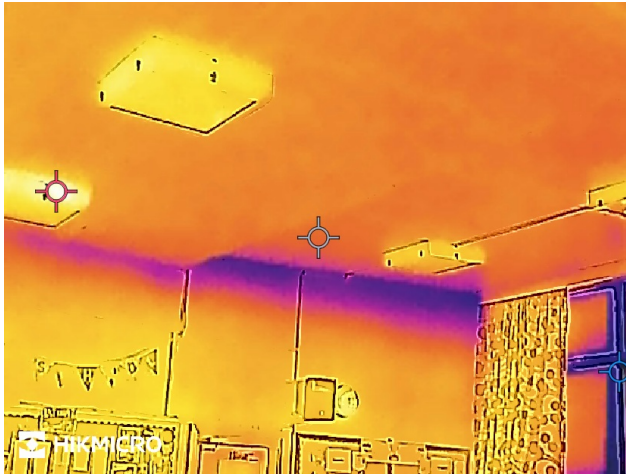
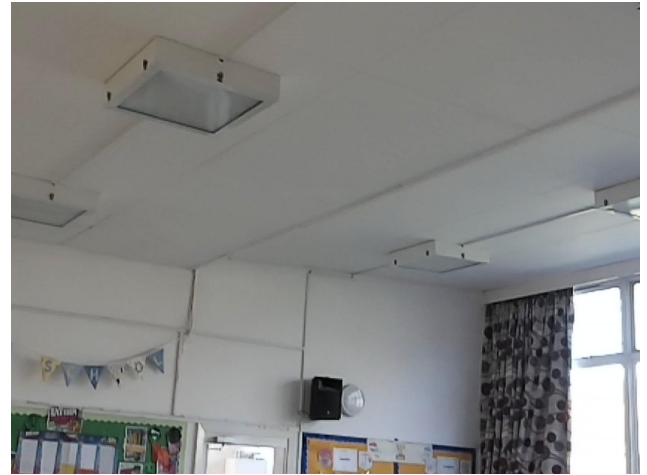
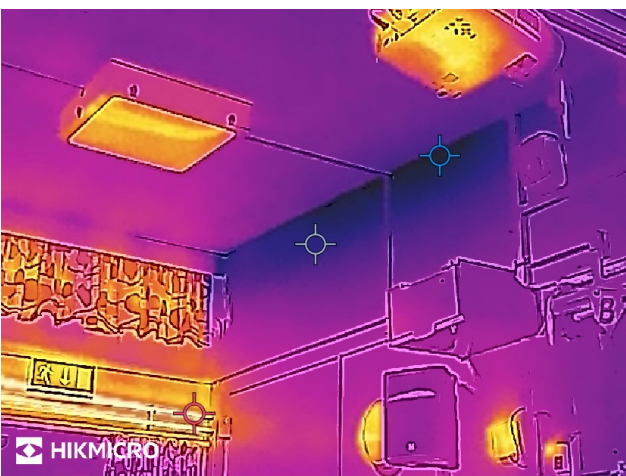
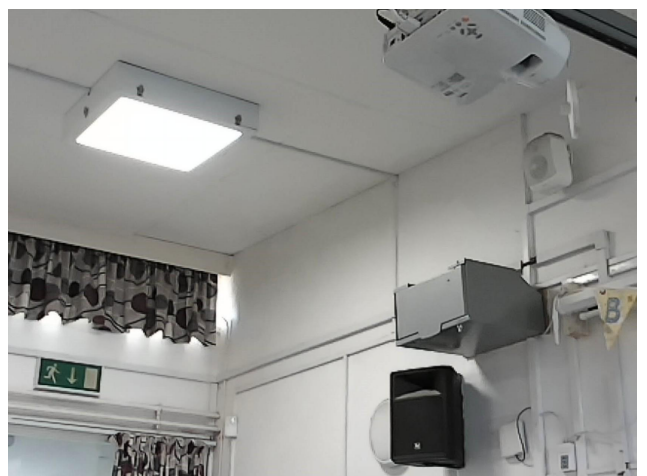
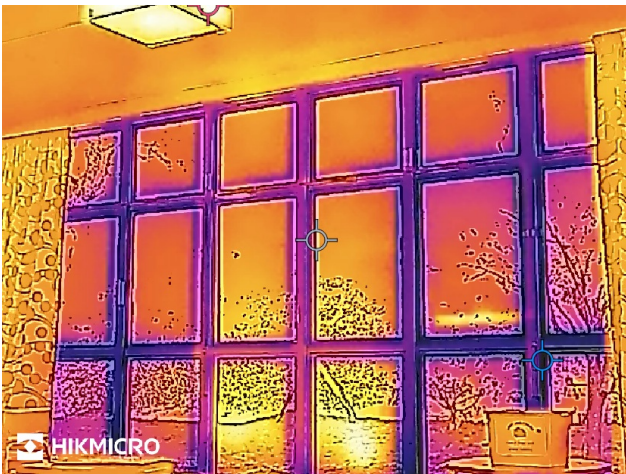
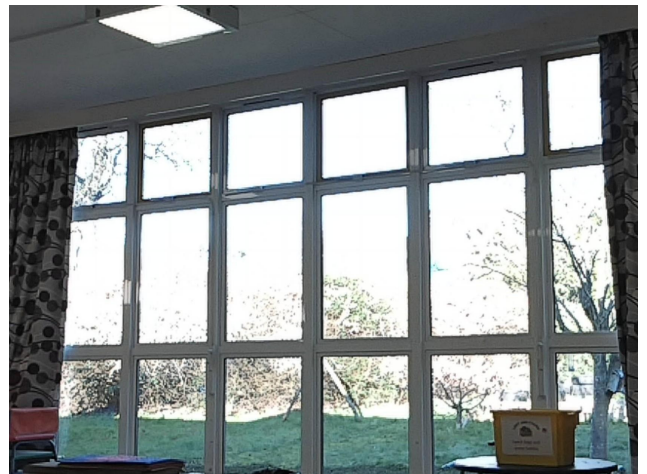
Finally, these images are from the main hall, showing that the top of the external wall is colder than the remainder. This is likely caused by the fact that cavity wall insulation is never installed to the very top of a wall, leaving these cold bands around the ceiling. Other than this, and the cold window frames that are consistent with the remainder of the building (which are being mitigated in this instance with thick curtains), there are no significant issues or opportunities for quick improvements that we can identify.
